**INDEPENDENT INVESTIGATION REPORT
INTO THE VERY SERIOUS MARINE
CASUALTY
OF
MV “GERHARD G.”
AT Rotterdam
ON 12 November 2014**

Flag: Antigua and Barbuda W.I.

IMO No.: 9534286 / Official No.: 4796 / Call sign: V2FD5

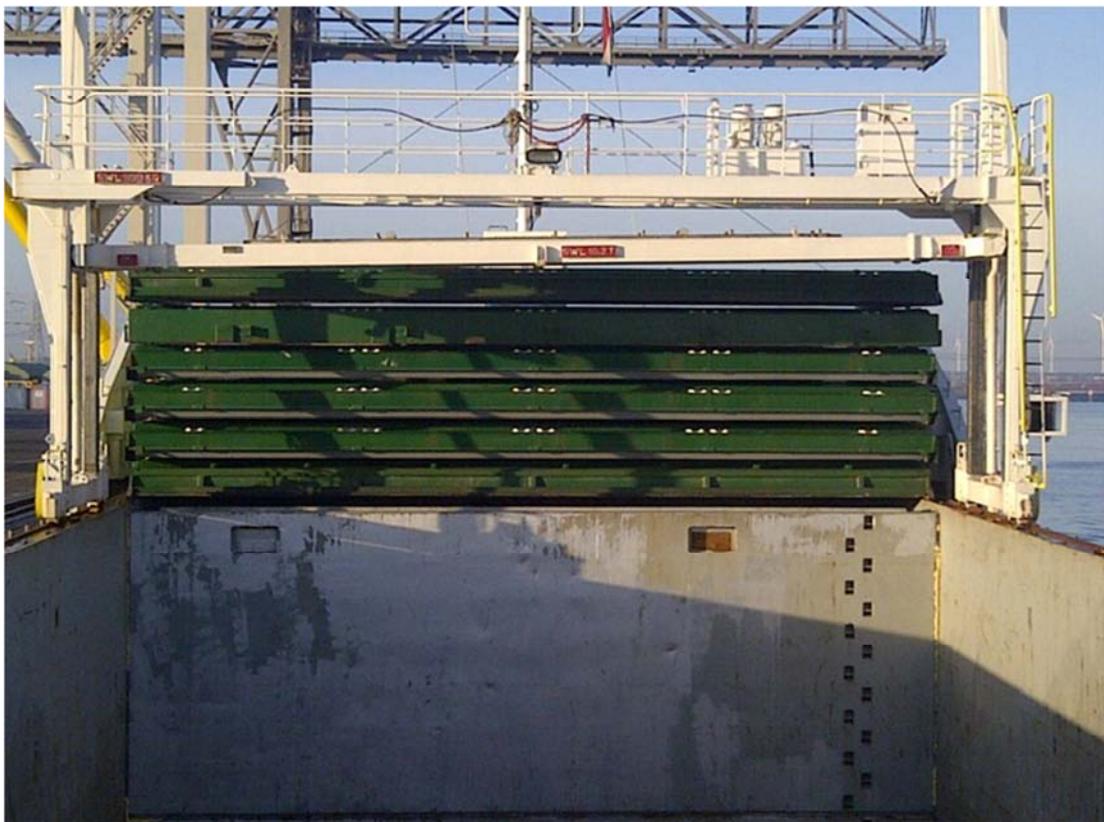
Hatch gantry view from aft and stacked hatch covers

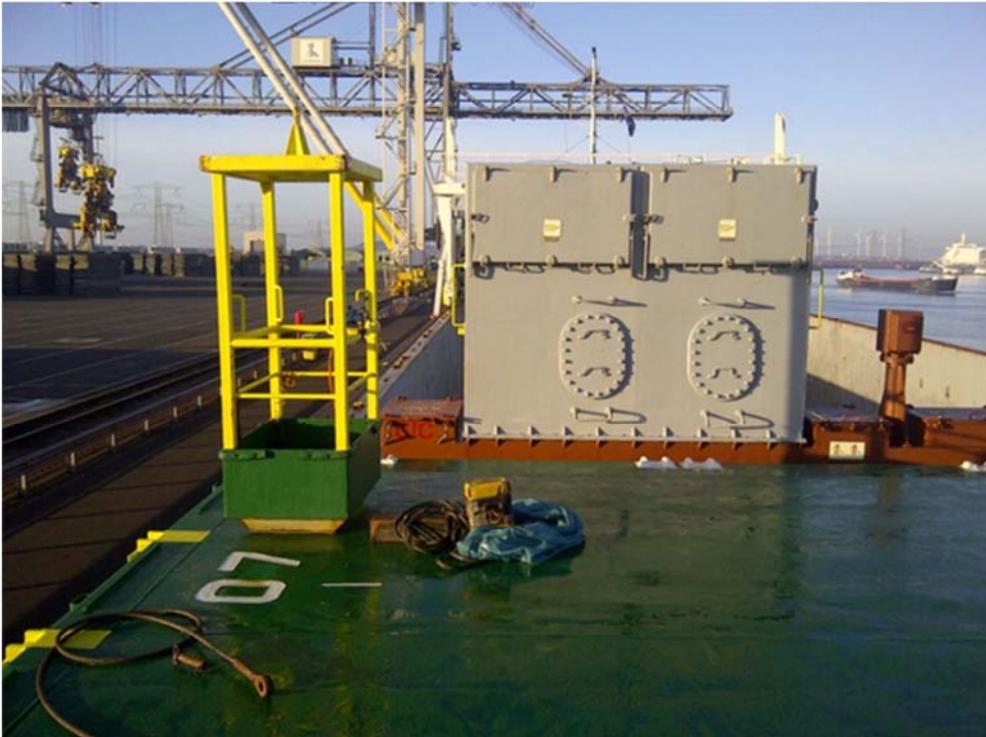
The only damage was to the electrical hoist/chain block and attached person basket that was deformed due to the fall into the hold.

Person basket and tackle on closed hatch

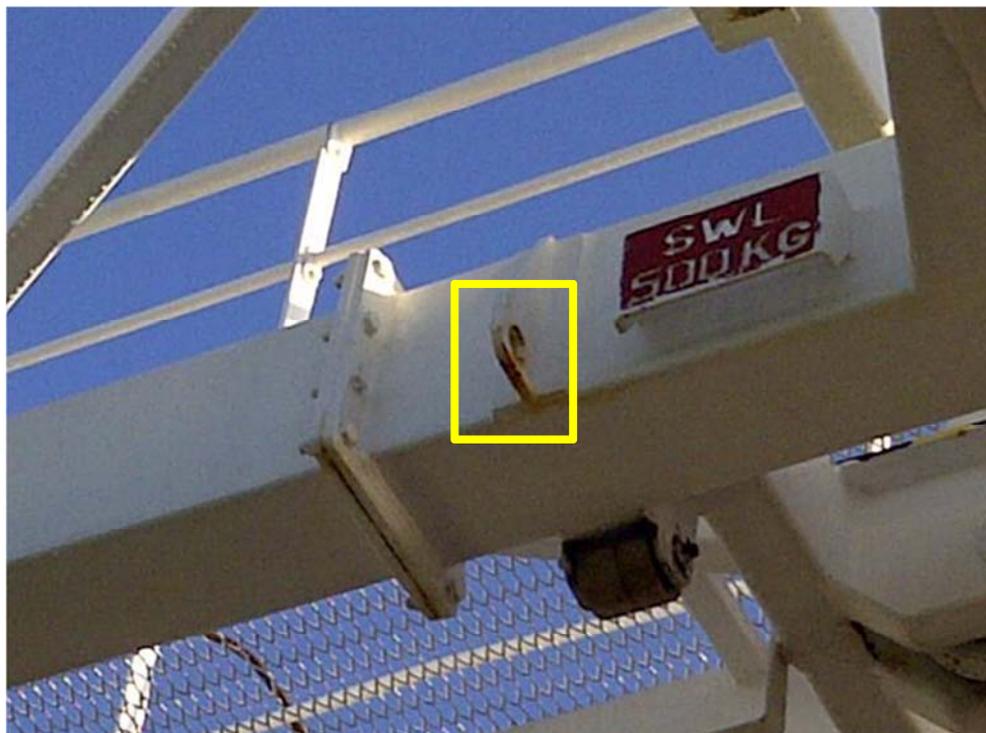
Point the hook is attached to

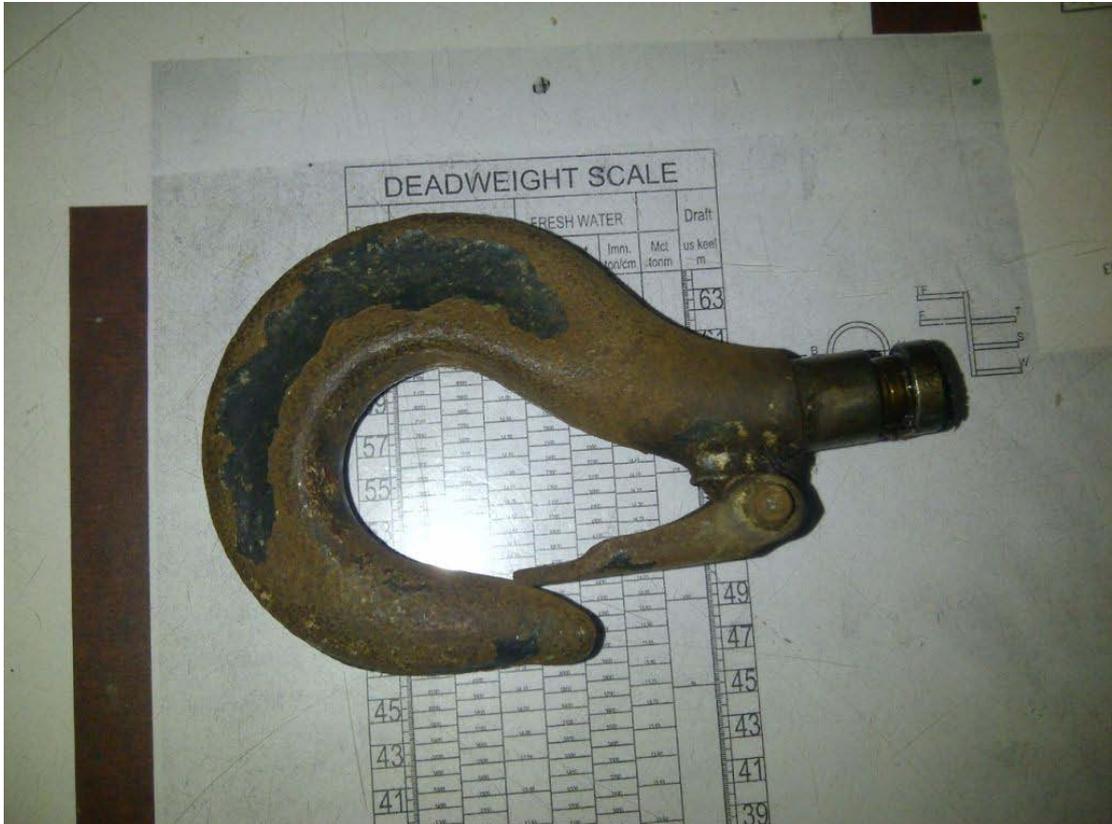
In order to detach the movable bulkhead from the cargo hold sides the able seaman lowered himself down by cable remote control in order to be able to reach the bulkhead locking pins to release these and move the bulkhead. This is when the hook holding the electric tackle and person basket on to the hatch gantry parted and caused the whole setup including the able seaman to crash into the hold. The able seaman was hit hard on the forepart of his head by the person basket, breaking the skull and causing instant death. The fellow crew on site were tragically not able to assist as the fall and collision with the person basket were too hard to let any chance of survival remain.

The meagre maintenance documentation and found state of the hook and tackle imply that the maintenance was (annual inspection by sight) not sufficient to prevent the casualty. The superficial check prior to setting up was not able to include the part of the hook that parted (swivel) as it is difficult to see the inner part without disassembling it. Thus, the first impression is that the maintenance was the primary causal factor.

Parted hook

ADOMS IID recommends that the testing and certifying authorities categorize the hatch gantry system, including the electrical tackle and person basket, as a lifting appliance when lifting by gantry or other crane takes place in order to assure the correct testing and maintenance including documentation or certification thereof.

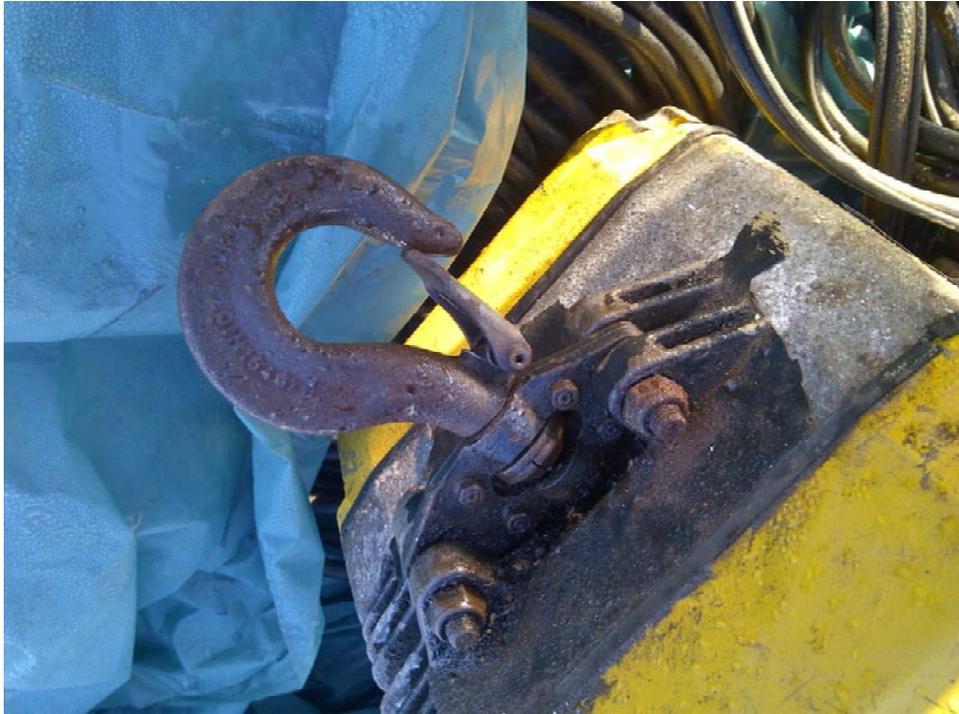
Intact 2nd electric tackle

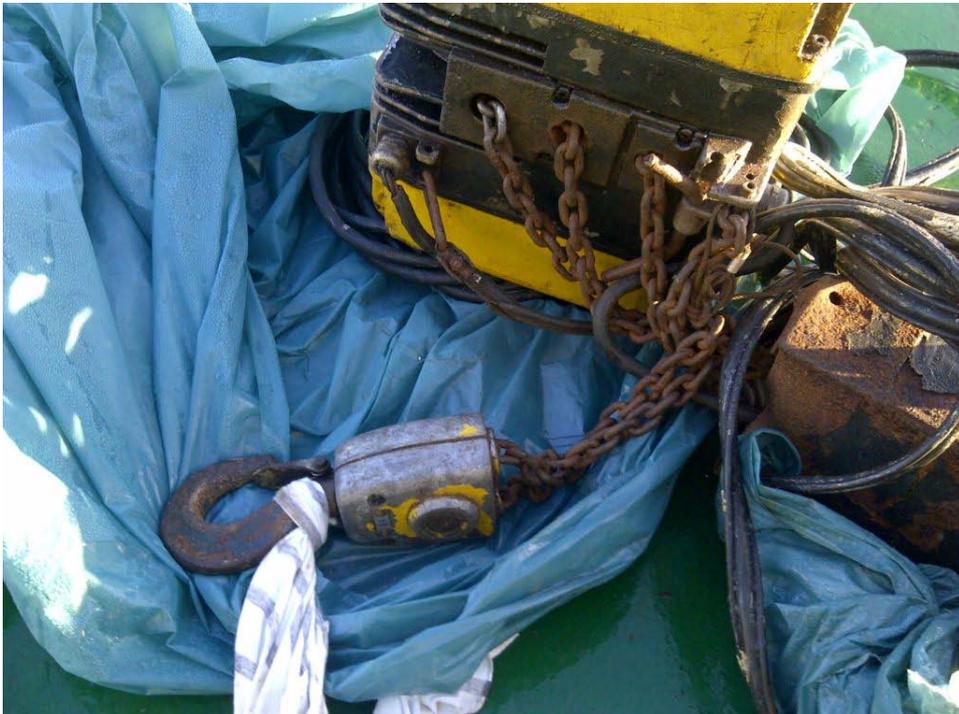
Intact lower part of tackle with working chain & hook

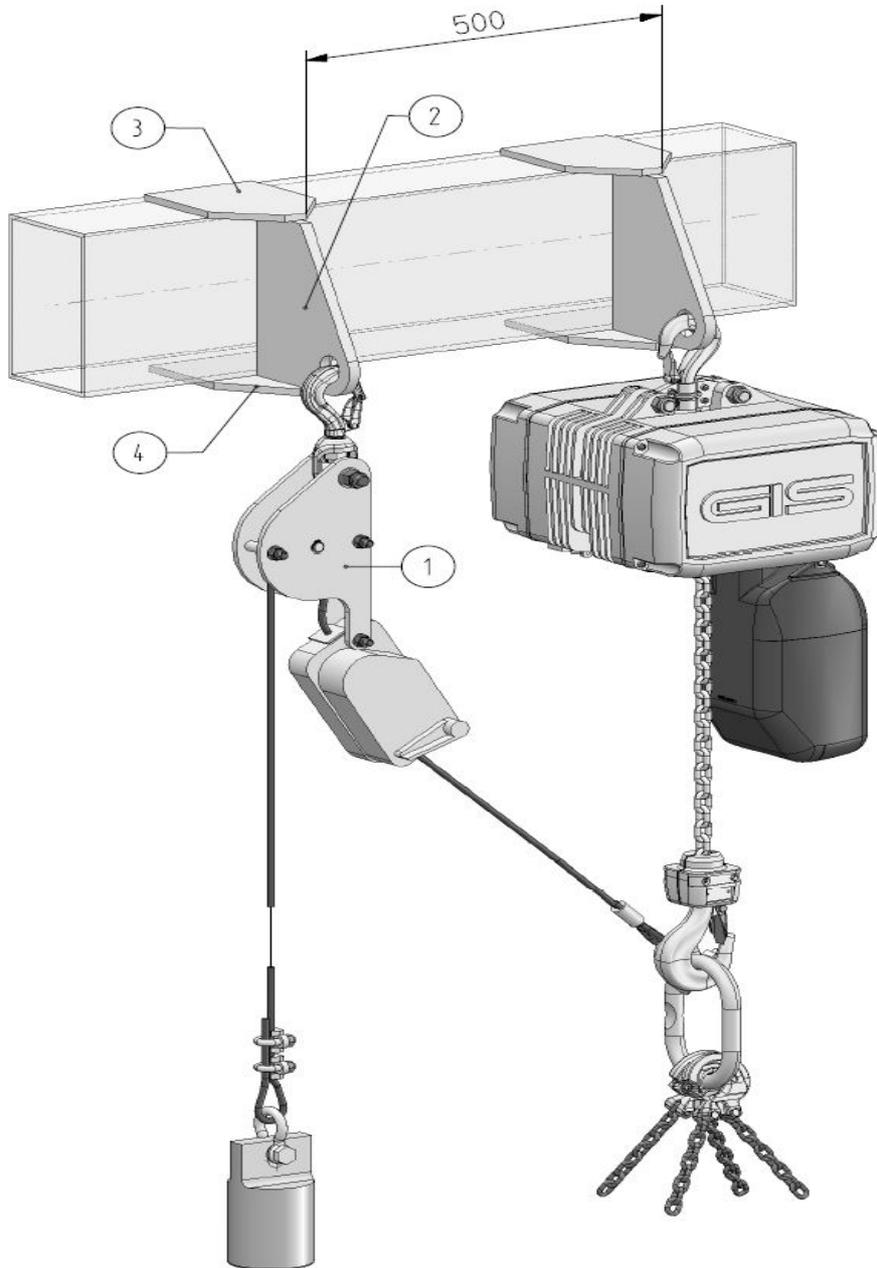
Fall arrest design drawing, Coops & Nieborg

Looking further than the vessel itself it can be said that the found different certification and consequent usage of the tackle to lift and lower persons in a basket made this very serious casualty possible more than once. During discussions with the hatch gantry crane manufacturer at their facilities, a possible solution (fall arrest that can be fitted to existing systems) was presented. This device was at the time still in the certification phase (see next page).

It was found that the majority of companies contacted the hatch gantry manufacturer and inquired about the possible technical measures that could be taken (i.e. fall preventer or arrest). Others informed that the person basket and the electrical tackle arrangement had been taken off the vessel on delivery as it was not deemed suitable and other methods were applied (i.e. remote hydraulic bulkhead securing pin control, ladders secured from above and as last resort no shifting of bulkheads).
