**INDEPENDENT INVESTIGATION REPORT
INTO THE VERY SERIOUS MARINE
CASUALTY**

MV “PALMERTON”

**AT North Sea Wandelaar Pilot Station leaving port of
ANTWERP, Belgium**

ON 22.11.2016

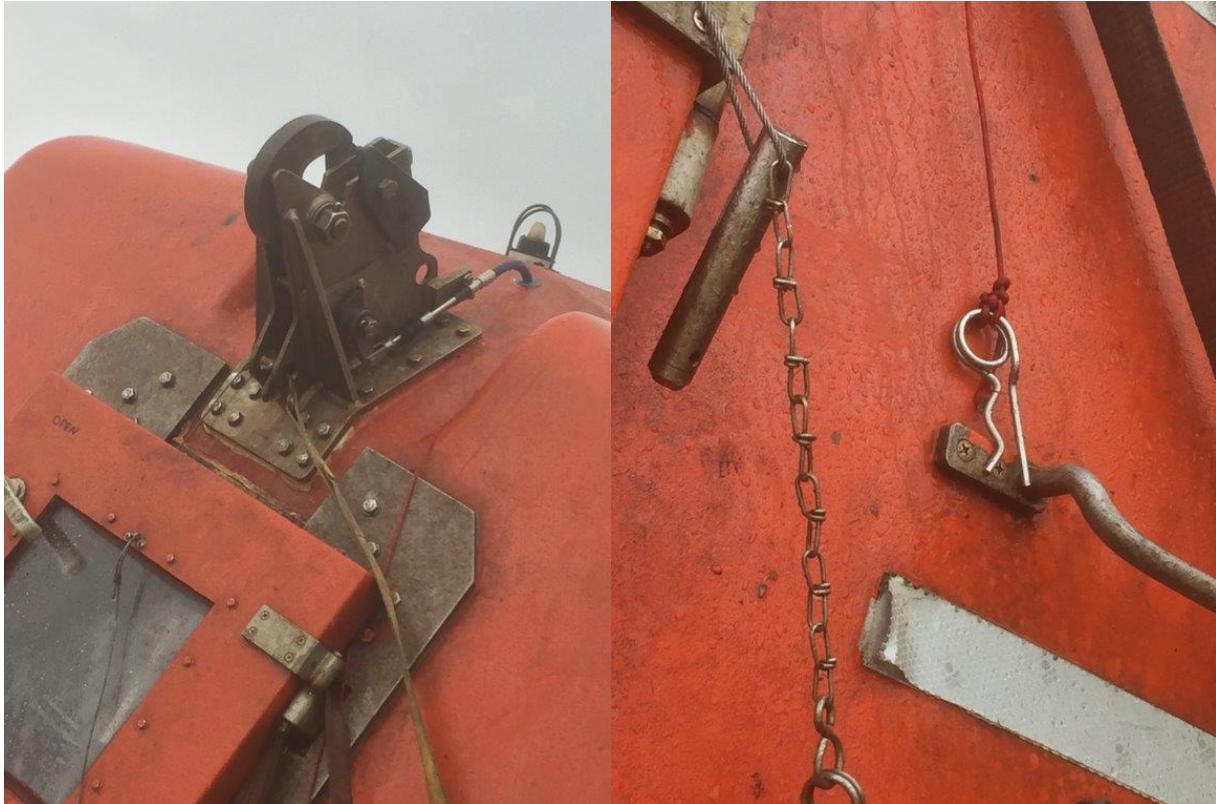
The 2nd officer's findings prior the departure of MV PALMERTON, the hook safety pin not movable or stuck, suggest, with the above findings, that the hook might have been already released when the crew commenced working at the accident scene. This also fits the statement in the lifeboat's Operator's Manual under the prefix *Caution*, advising to secure the boat before checking the system (see next page for quote).

Lifeboat hook as found after retrieval from sea with both safety pins (source: taken on scene)

If release hook safety pin cannot be removed off the hook casing without excessive force, the hook might be released. Secure boat release hook and check system.

Finding the release hook safety pin stuck and not able to be moved suggest that this open position as pointed out in the Operator's Handbook was left behind most possibly by the service company having not reset the hook position fully but in a more open position. When the crew then tried to free the safety pin as instructed by the officer responsible, the hook released fully allowing the boat to launch in free fall to sea as no maintenance securing or simulated launching device was attached.

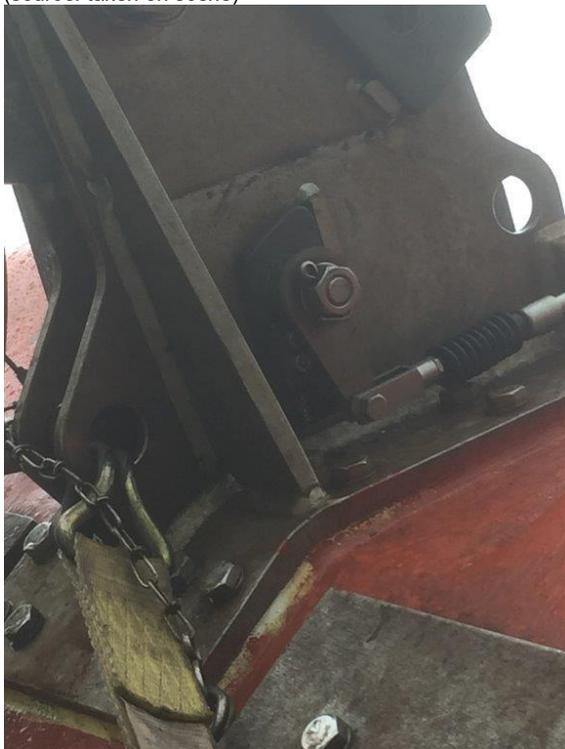
As both involved crew members were the only persons on scene and both tragically lost their lives, no information or details on the how the work was practically conducted and how the situation evolved at the life boat could be assessed. The positions of either crew members cannot be reconstructed. The launching arrangement on board showed no signs of failure or damage. The release of the free-fall lifeboat seemed to have technically taken place as intended from an on board point of view. It was clearly to be seen that the life boat maintenance securing or simulated launch device cannot have been connected at the time of the unintended release. The assessment of the lifeboat when landed ashore also showed no signs of damage or failure. All was found in a position expected when the boat is released except for a covering plate that was detached and later found on the boat deck. The safety bolt and split splint where both attached to their cords and hanging down the side from the hook fixing. The release bolt with attached lever to allow release from the inside of the boat was found in a nearly open position. The closed position would have had to be approximately 30° more in aft direction, but no indicator that the release segment and mechanism had been correctly reset is installed to clearly show the required closed setting. It could not be assessed if this position was left by the service technician or later caused by the work on the release system by the vessel's crew. The inside helmsman release was found untouched and in a closed position.

Below: Release Bolt lever for release from inside
(source: taken on scene)

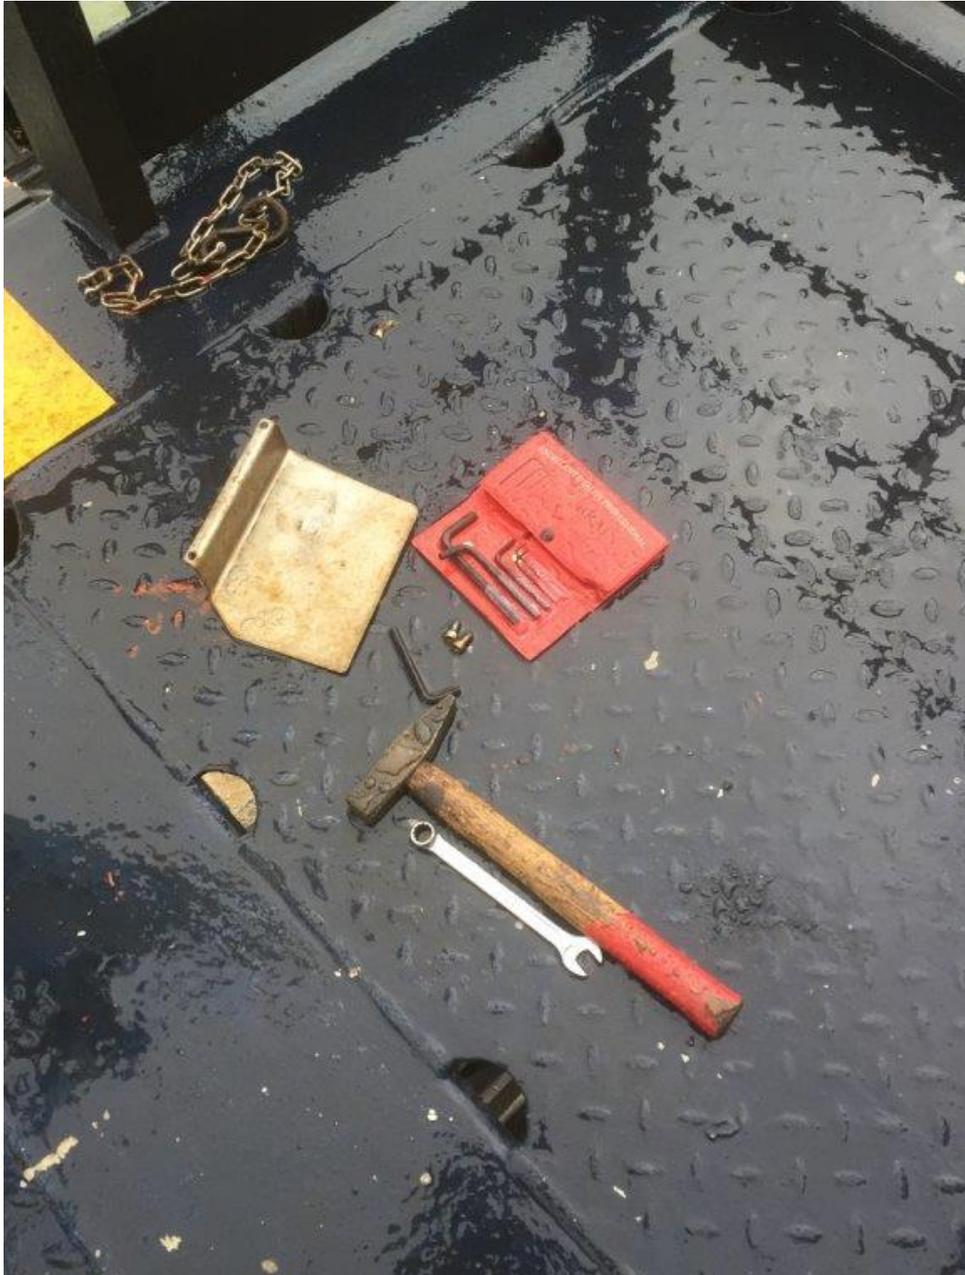
Tools and hook covering plate as found on the lifeboat deck (source: taken on scene)

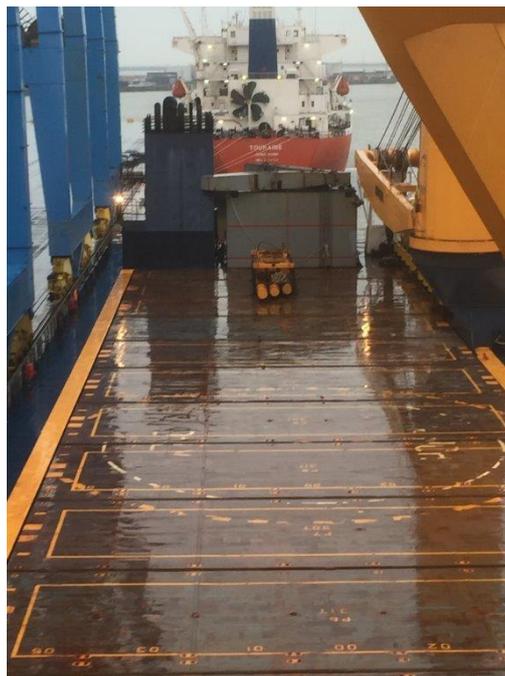
The supervising 2nd officer had prepared the check on the hook configuration on paper and verbally instructed the crew members but had not checked the situation at the boat deck as he was still on navigational watch approaching the Wandelaar Pilot Station. Due to the vessel's construction with a forward located accommodation and navigational bridge and the lifeboat deck at the stern it was not possible to see the area where the two crew members were working.

View from aft of the bridge to the stern of the vessel where the lifeboat is situated behind the funnel (source: taken on scene).

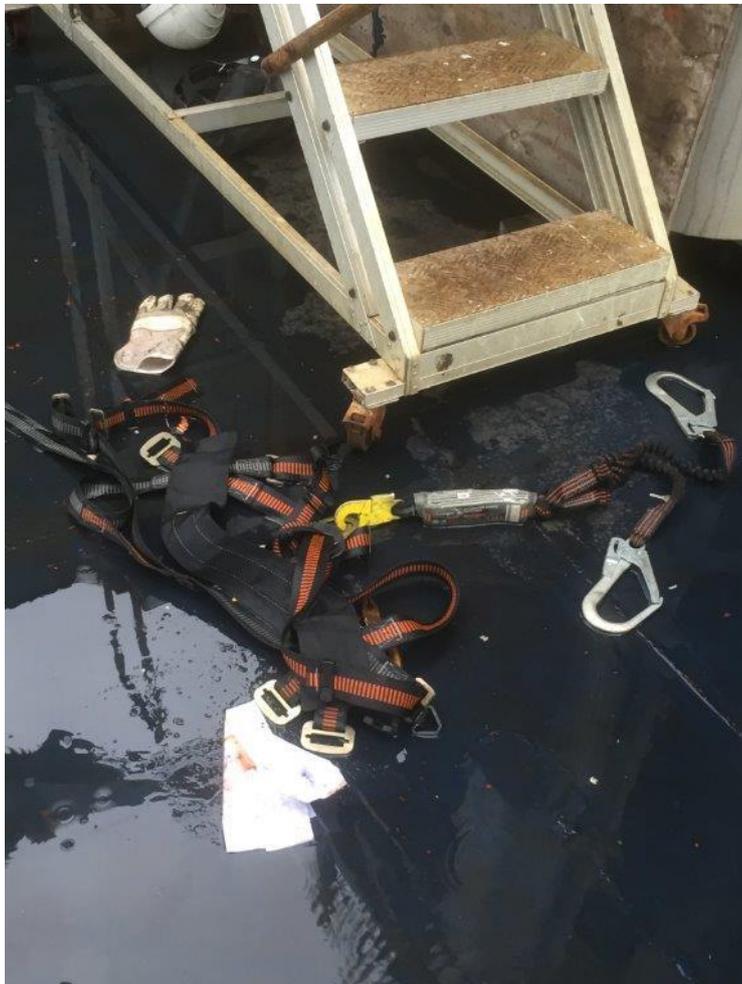
In addition Personal Protective Equipment was available and taken to the lifeboat deck but not used. The safety harnesses were lying on deck and had not been donned as required by the company safety procedures laid down in the SMS.

Safety Harness as found on deck (source: taken on scene)

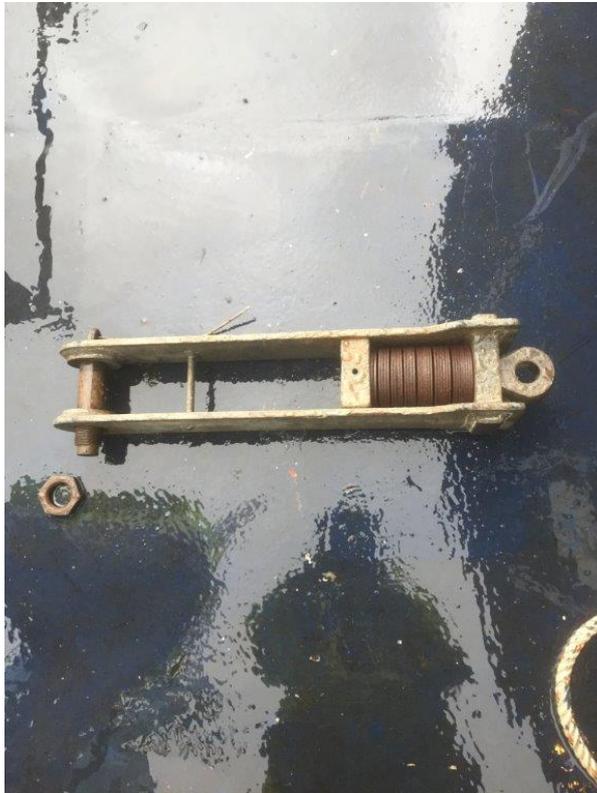
Simulated launching device found detached on deck
(source: taken on scene)

- No maintenance securing or simulated launching device was applied before working on or at the free-fall lifeboat
- The company SMS procedures were not adhered to in practice before and during the execution of the instructed task. A tool box meeting was held discussing the intended work, a risk assessment was made and written up and a permit to work form for working aloft issued by the responsible officer and confirmed by the nominated crew members. In practice all three pre work actions were not adhered to.

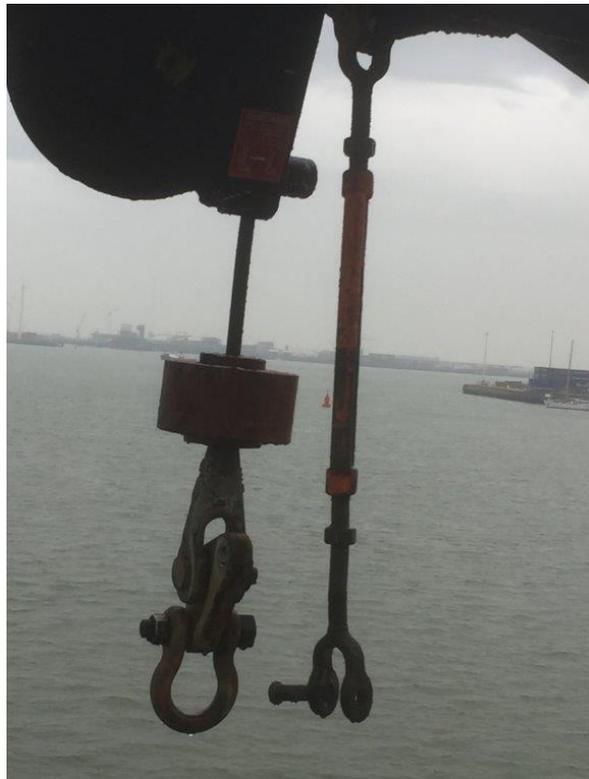
Davit hook and securing connection detached/open
(source: taken on scene)
