**INDEPENDENT INVESTIGATION REPORT
INTO THE VERY SERIOUS MARINE
CASUALTY**

MV “FRANCOP”

AT Dublin, Ireland

ON 14th of November 2018

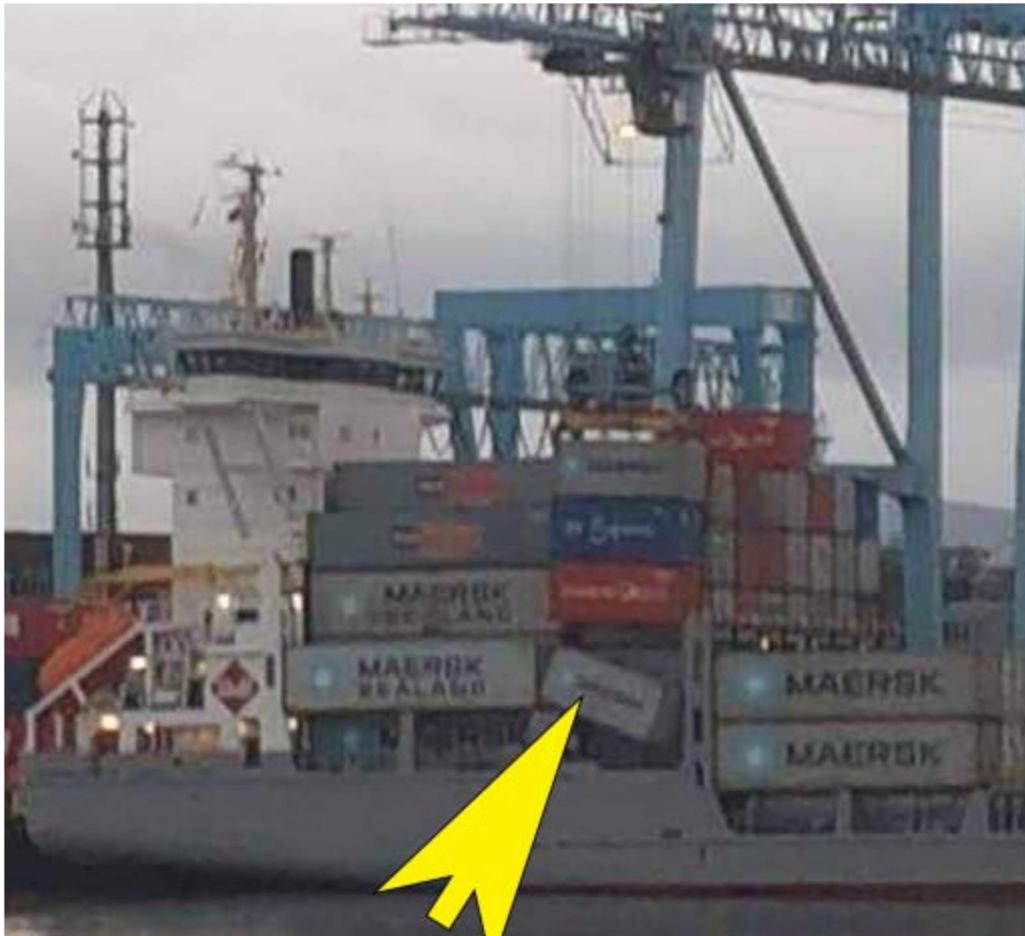
Lifting was immediately stopped, but as direct reaction and to free his colleague the OS ordered the crane to lift and release the injured AB. Upon moving the stack and freeing the AB the connections on the top of the bottom container failed, causing it to crash down onto the AB lying on the platform after having already been severely injured.

MV FRANCOP aft starboard side showing suspended stack and detached, crashed down bottom container (Taken on scene directly after accident)

During the on scene investigation it was found that between the containers in tier position 84 and 86 (lowest and the above container of the stack of 4) the forward seaside corner position was only secured by a midlock, which was found to have broken, most probably when the stack of containers was lifted with the intention to free the later deceased AB.

The use of a less strong connecting device (midlock) on one outside corner to secure the bottom container with the above, in contrary to all other connections between the stack of 4 containers where Semi-Automatic Twist Locks were used. The midlock does in practice not securely connect containers but only holds them in position.

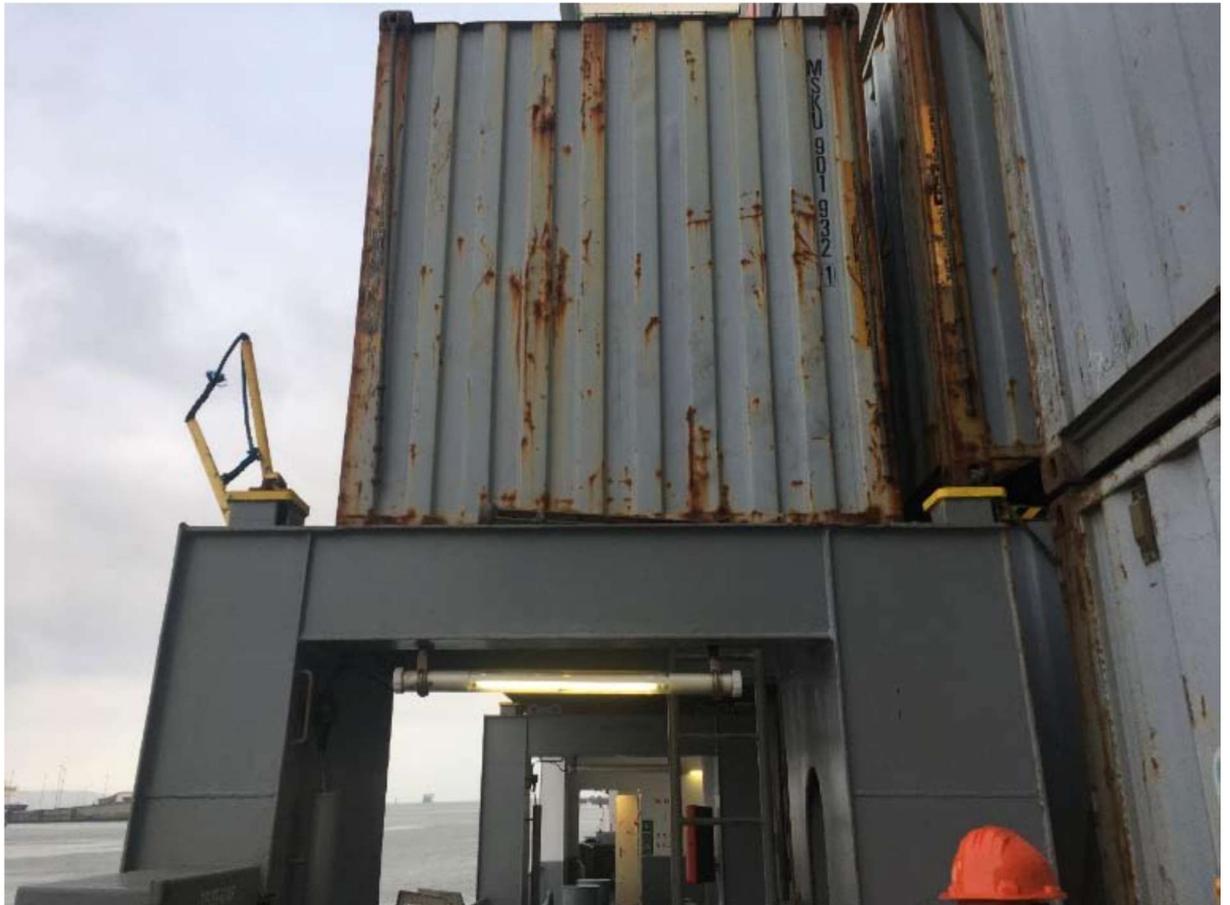
Upon go ahead given by the AB via handheld radio to the crewmember ashore next to the stevedore foreman, who in turn instructed the shore contracted crane operator, the container stack was lifted slightly from its position. The AB tried to apply the twistlock but failed as the space given by the lift was not yet sufficient. This prompted the AB to ask for further lifting by the crane which was duly executed. Through the increased lift and achieved space the container freed itself from the before still restraining other three twistlocks and as a result swung toward the AB, pushing him against the container behind him with a strong moment. The OS standing under the AB's position immediately informed the shore side colleague that lifting is to be stopped and noticed the AB was still held between the suspended container stack and the fixed stack behind, bleeding from the mouth.

Position of AB looking aft onto platform and adjacent most astern stowed container on starboard side (taken on scene)
