**INDEPENDENT INVESTIGATION REPORT
INTO THE VERY SERIOUS MARINE
CASUALTY**

MV “FAIRPLAY-33”

AT Mekjarvik, Randaberg, Norway

ON 02.04.2020

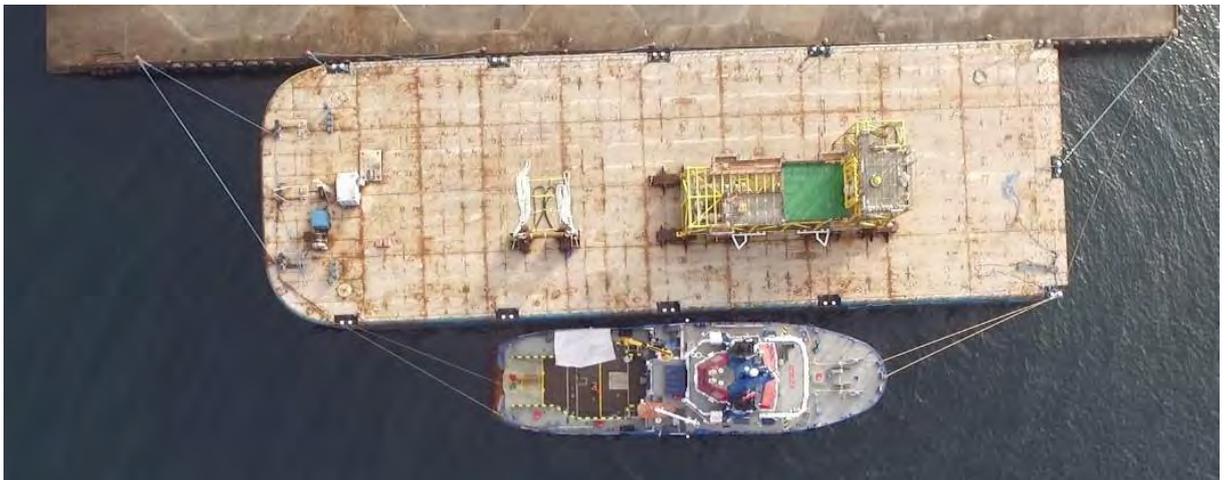
At 10:00 LT the wind turned to the North to NNW with an increase to 7 to 8 Bft, creating a situation in which the tug was being pushed against the barge. The situation apparently worsened over the day and the movement of both barge and tug increased, also worsening the contact intensity between the two.

Berthing situation

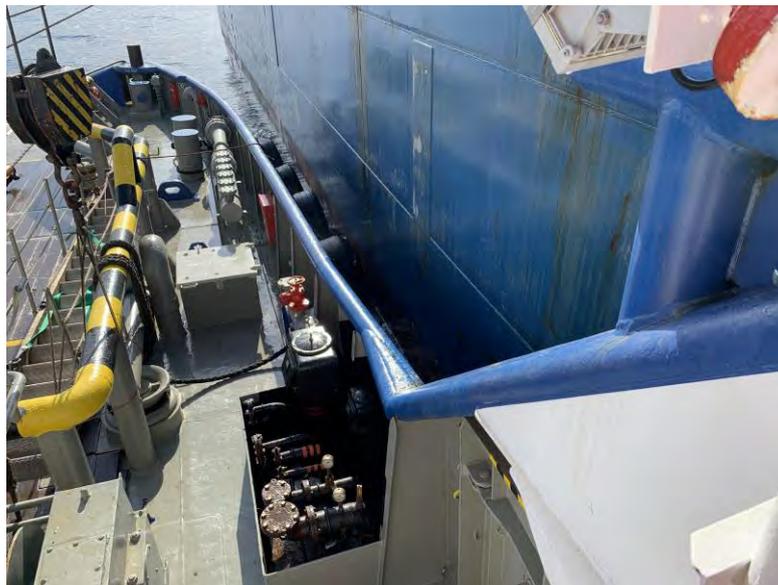
An instant later the 2O also fell into the water between the tug and barge prompting the just arrived CO to shout out Man Over Board.

With assistance of all crew the 2O was retrieved first, holding on to one of the large fenders and a short moment later the AB was retrieved too having ceased holding himself above water a moment before.

Position the 2O was retrieved from the water

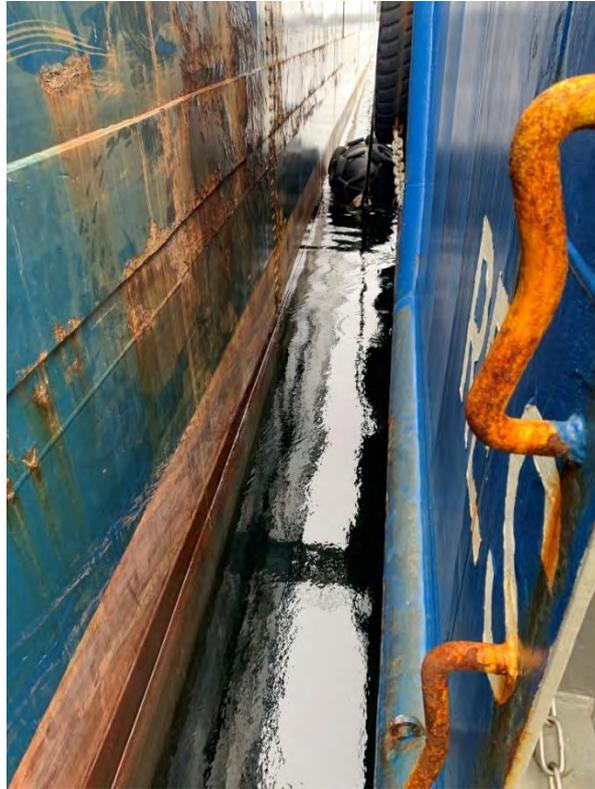
Space between tug and barge looking forward

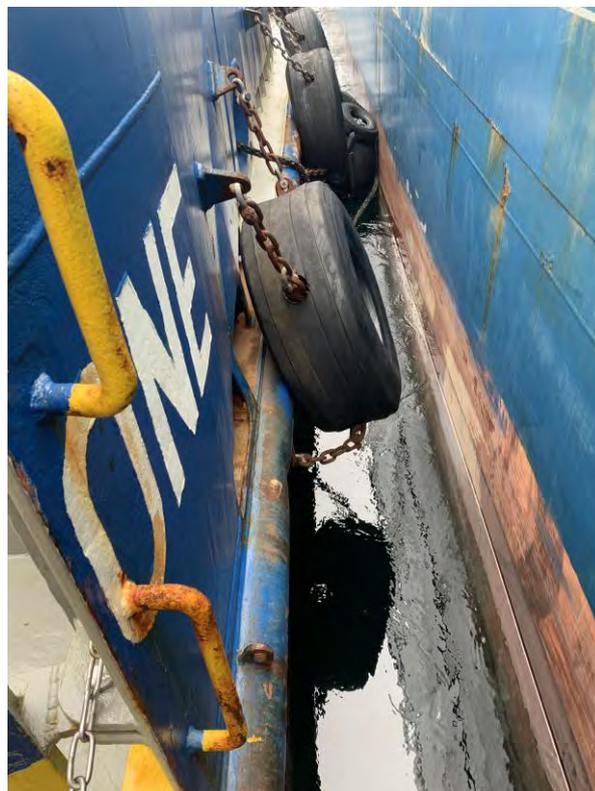
Position looking aft

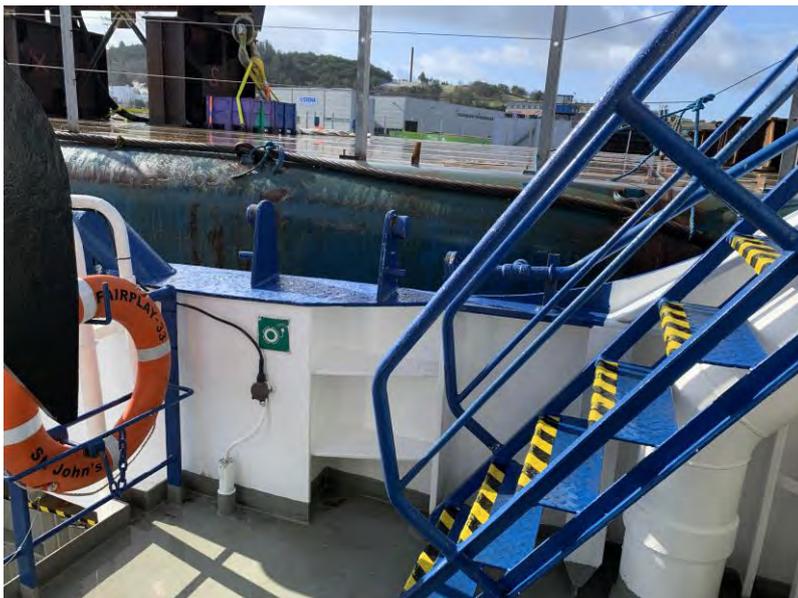
AB1 together with the CO and 2O were tasked to prepare the alongside barge to be disconnected from FAIRPLAY-33. The tug and barge were attached by lines but no means of boarding were brought out. This prompted the CO to jump from the tug onto the barge without any safety measures applied, indicating that this was regarded as a routine action on FAIRPLAY-33.

Accident location

The position on the edge of the vessel, without a harness to secure himself and not having informed the 2O before, created a high risk of falling into the water, which in consequence happened.

The company is recommended to establish clear procedures in relation to transfer of persons or equipment between vessels and/or shore. These procedures should include at sea and in port situations.

Vessels should be equipped with means of safe transfer, including fitting gangways and/or other transfer means in order to prevent unnecessary risks to personnel when executing appointed tasks.

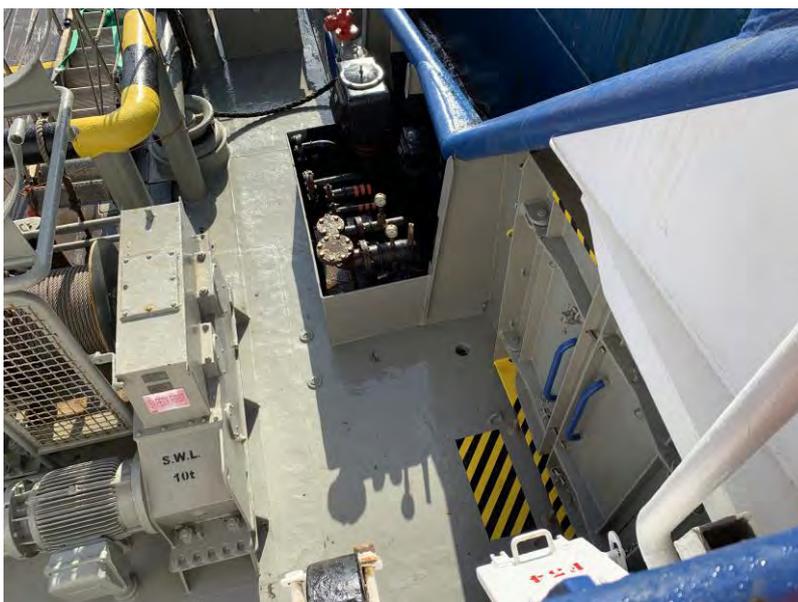
Further the AB1 was wearing a life jacket described as working life jacket. These are not part of the safety equipment of the vessel. The life jacket worn was not equipped with a crotch strap to prevent the jacket from moving out of position upwards towards the head, thus not giving the intended support, especially once the AB1 lost consciousness.

Rescue Zone on port side
