INDEPENDENT INVESTIGATION REPORT INTO THE VERY SERIOUS MARINE CASUALTY

MV “CLAVIGO”

Grounding leading to Total Loss

off Tuzla Port, Turkey

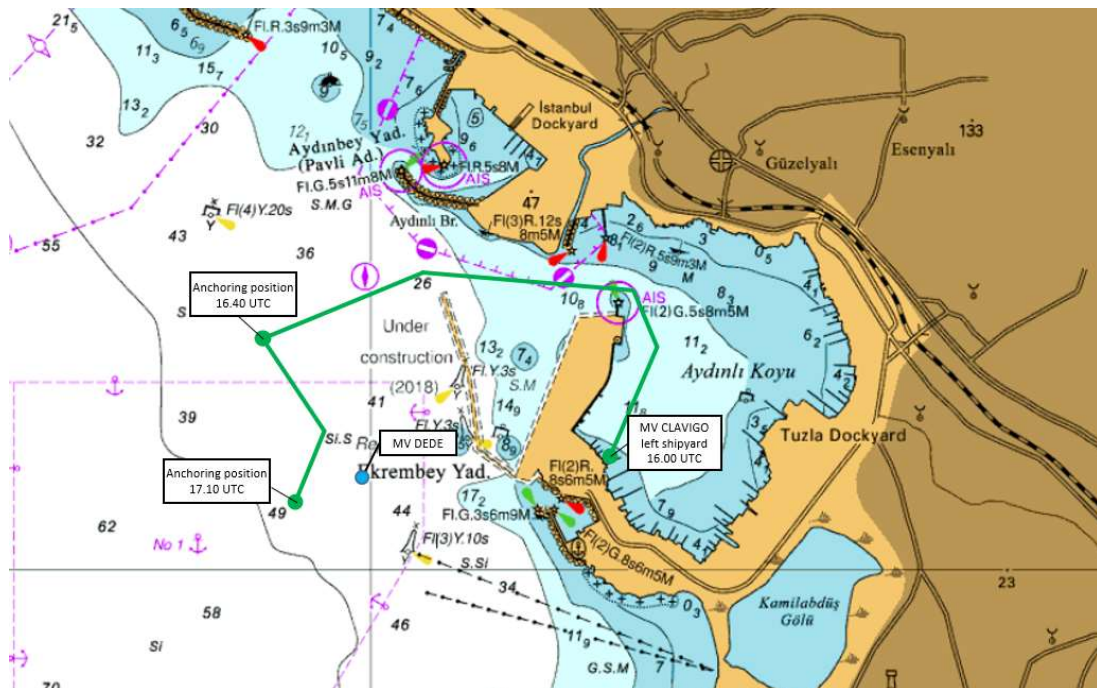
MV CLAVIGO's route to anchor position

The Master of MV CLAVIGO moored the vessel in position as instructed by the local traffic control station. A position chosen beforehand was deemed unsuitable by traffic control and thus the vessel was repositioned as instructed.

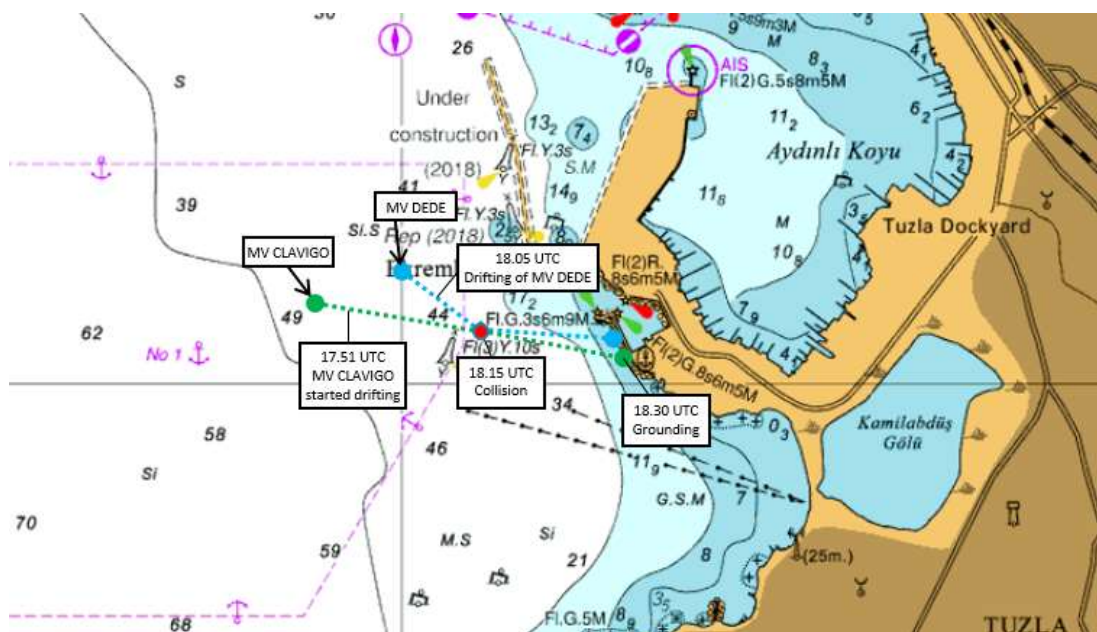
MV CLAVIGO's and MV DEDE's path of drift

MV CLAVIGO continued to drag anchor and despite all efforts to prevent the vessel from drifting towards the coast and colliding with other drifting vessels, such as the MV DEDE (IMO 7827354), all attempts proved unsuccessful, culminating in the unfortunate grounding of both vessels on a southern breakwater in the port of Tuzla. The MV CLAVIGO and MV DEDE were later declared total losses and scrapped in Turkish yards.

18:18	Vessels drifting towards breakwater together
18:20	Traffic Control informed tug was underway from Haydarpasa Terminal, ETA 1h
18:30	MV DEDE ran aground on breakwater, MV CLAVIGO separated, engine full ahead, rudder hard starboard, no use, too late, MV CLAVIGO ran aground, left parallel to breakwater (port side) at Tuzla port

Also, as per current industry practice and understanding, the water depth at the chosen anchorage would have warranted more chain to have been let go. The chain length is generally to be set at three times the water depth plus 90m under normal conditions and four times plus 150m in rough weather conditions. MV CLAVIGO had been anchored with 6 to 7 cables of chain in a depth of about 48 m, thus missing about 5 more shackles in the water under given circumstance.
