**INDEPENDENT INVESTIGATION REPORT
INTO THE VERY SERIOUS MARINE
CASUALTY**

MV “PALMERTON”

**AT North Sea Wandelaar Pilot Station leaving port of
ANTWERP, Belgium**

ON 22.11.2016

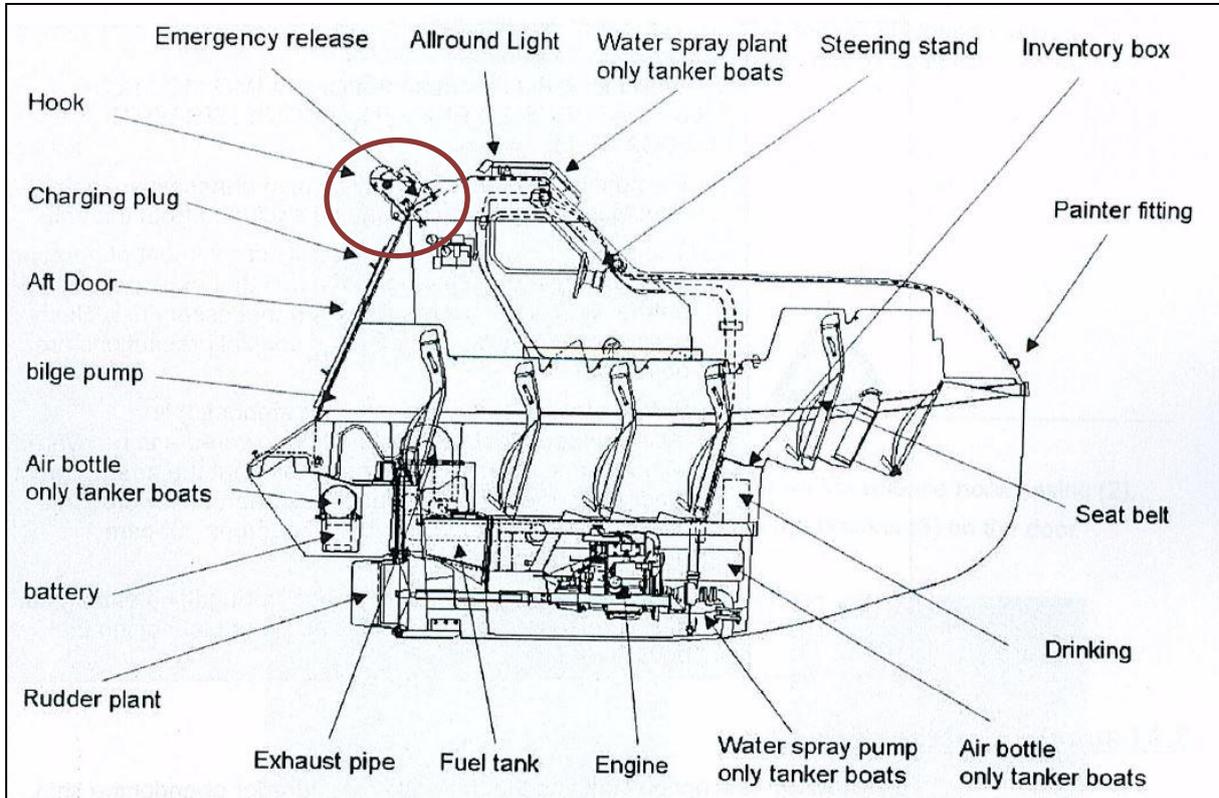
Overall drawing (source: Fassmer handbook on board)

On the next morning before departure the 2nd officer, also nominated safety officer, noted that the life boat release pin at the hook position at the aft top of the boat was fixed in position and could not be moved. This was not as expected and prompted the 2nd officer to discuss the matter with the master and vessel's bosun, who agreed to look into the problem during the day.
